VALDEZ NEW BOAT HARBOR PHASE 1 - UPLANDS

CONSTRUCTION PROGRESS REPORT No. 16 AUGUST 17, 2015 – AUGUST 23, 2015

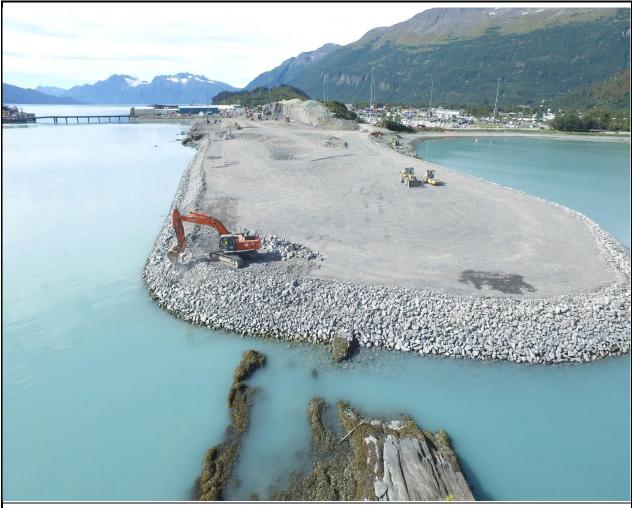
View West. Placing riprap over filter rock to protect the fill placed to construct the east extension of the uplands. Each 1' foot lift of crushed fill material is compacted by 6 passes of vibratory roller. (image by J. Talbott, COV)

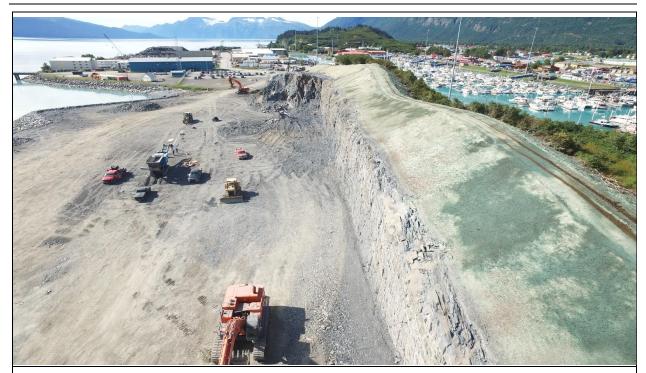
View West. Bedrock has been shot and excavated to subgrade (2' below pavement) except for NW and small knobs at NE. Rock cut in center is 1'Hor. per 4'Vert. Topsoil on upper 2:1 slope was hydroseeded. (J. Talbott, COV)

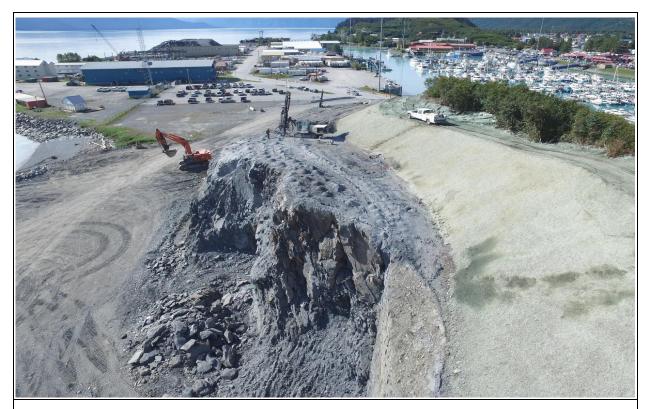
Drilling toward west access drive to shoot bedrock with "backsplit" that creates 1:4 final slope. (J. Talbott, COV)
